ALTERED HYDROLOGY – EFFECTS ON POOL 7

Jon Hendrickson and Kim Warshaw, St. Paul
District Corps of Engineers

Presented to the Lake Onalaska Rehabilitation
District

Nov 19, 2020

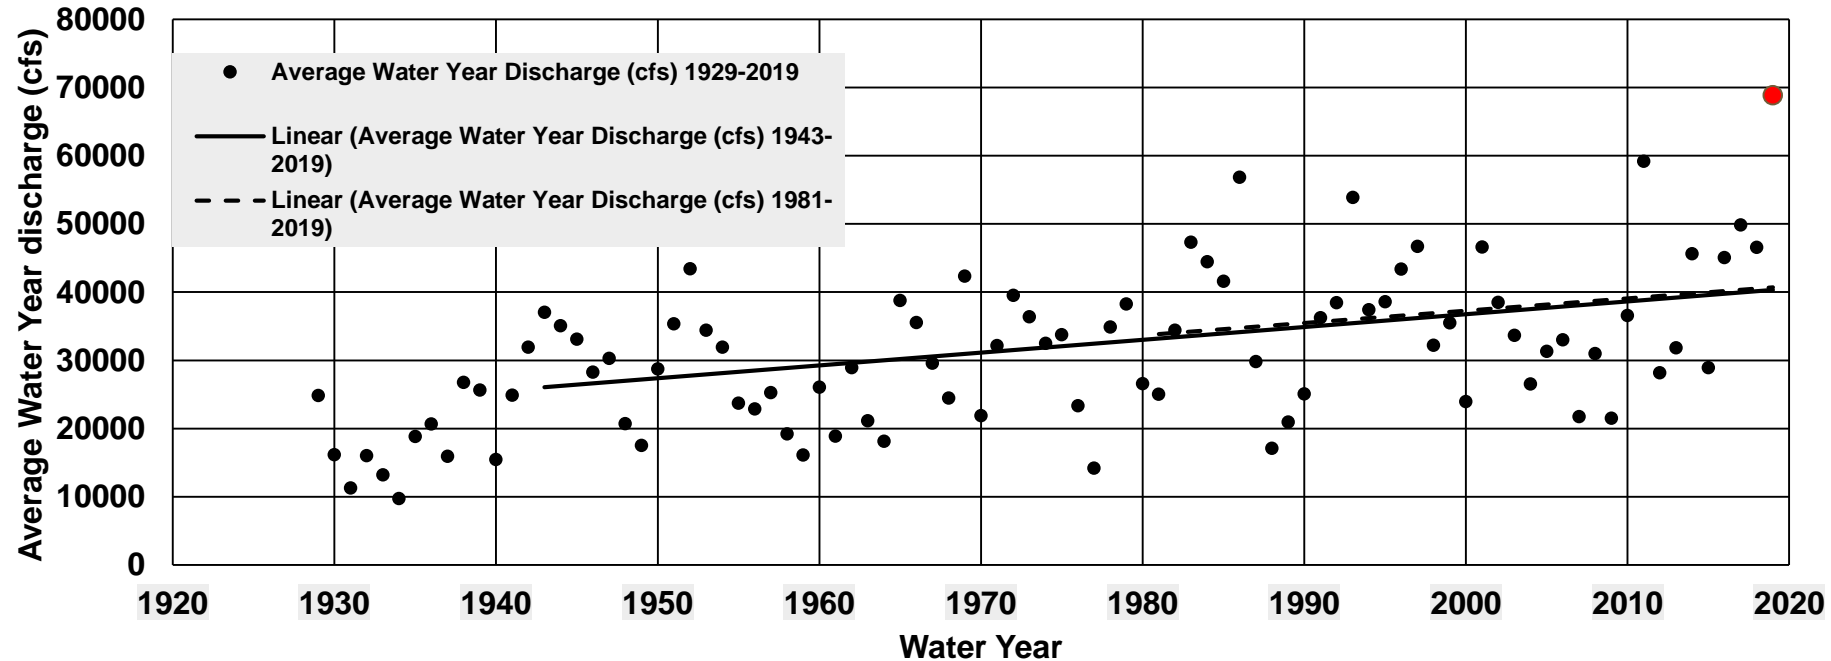
Mississippi River at Winona, Minnesota (USGS Gage 05378500)

ANNUAL FLOW VOLUMES

Average Water Year Discharge at Winona
1943 to 1980 = 29,000 cfs
1981 to 2019 = 37,300 cfs (28.6 % increase)

2016, 2017, 2018, 2019 = 45,000, 48,000, 51,000 and 69,000 cfs
2010 to 2019 is wettest decade on record

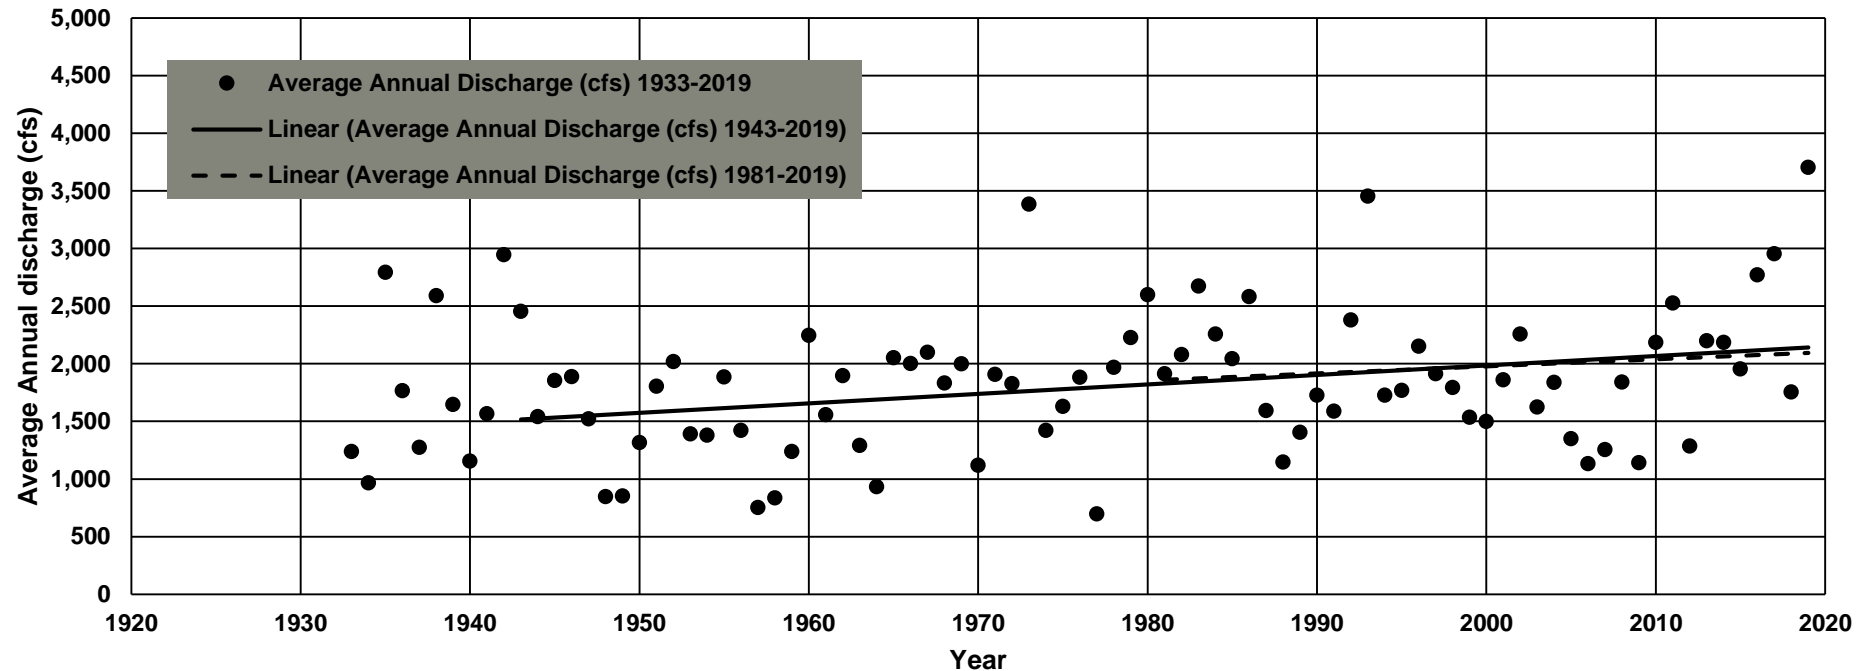
Black River Near Galesville, Wisconsin (USGS Gage 05382000)

ANNUAL FLOW VOLUMES

Average Water Year Discharge at Galesville

1943 to 1980 = 1,675 cfs

1981 to 2019 = 1,978 cfs (18.1 % increase)

2016, 2017, 2018, 2019 = 2773, 2957, 1758, 3705 cfs

2010 to 2019 is wettest decade on record

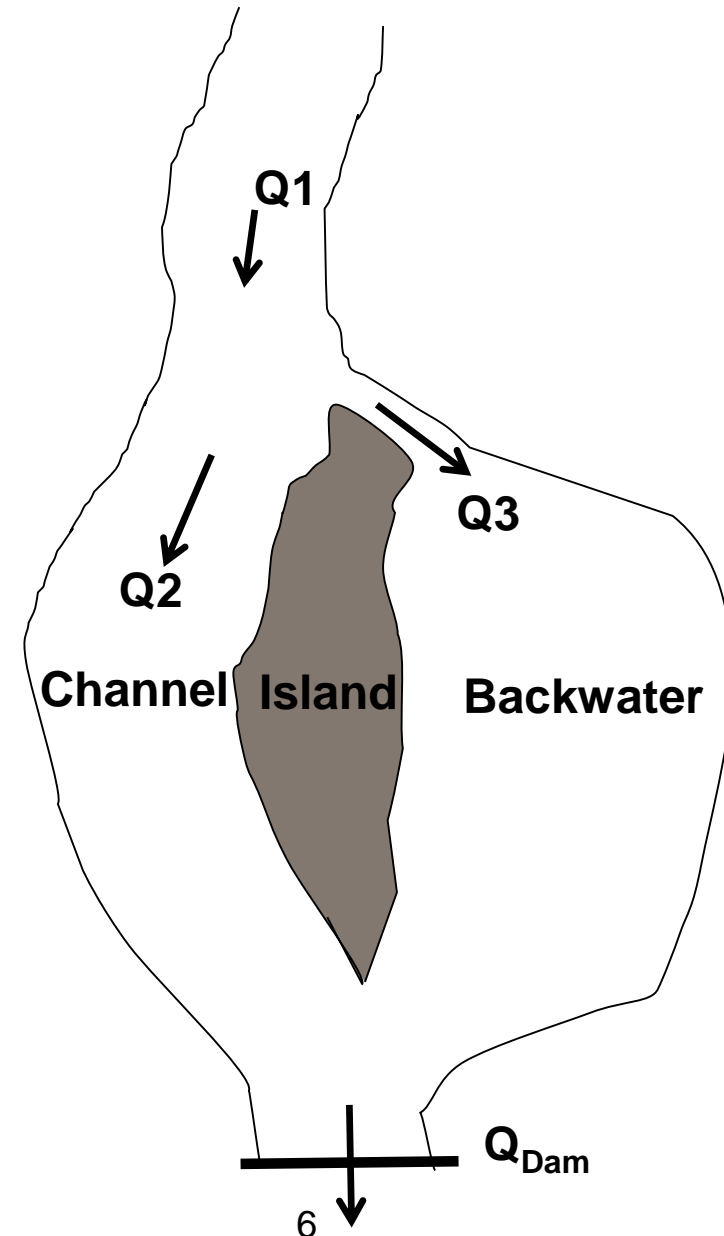
WATER EXCHANGE

In this example, the water exchange ratio between the channel and the backwater is

Q_3/Q_{dam} where Q = river flow

Expressed as a ratio or percentage

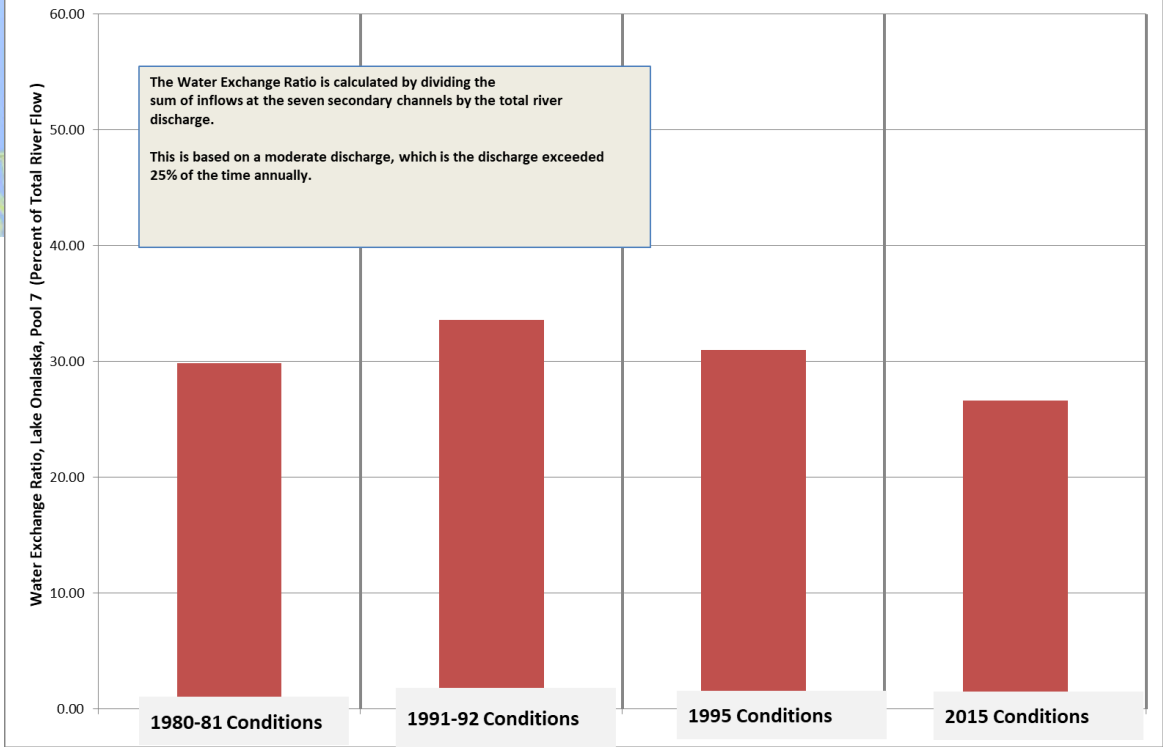
Water Exchange Ratio: Lake Onalaska, Pool 7

The Dakota Navigation project was constructed in 1994

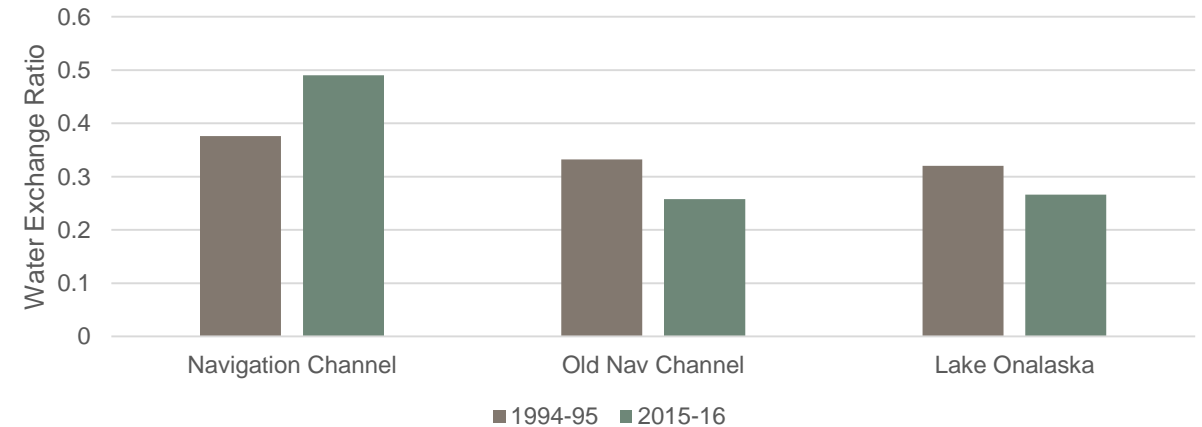
Change in Water Exchange Ratio
Lower Pool 7

WATER EXCHANGE - A SURROGATE FOR GEOMORPHIC CHANGE

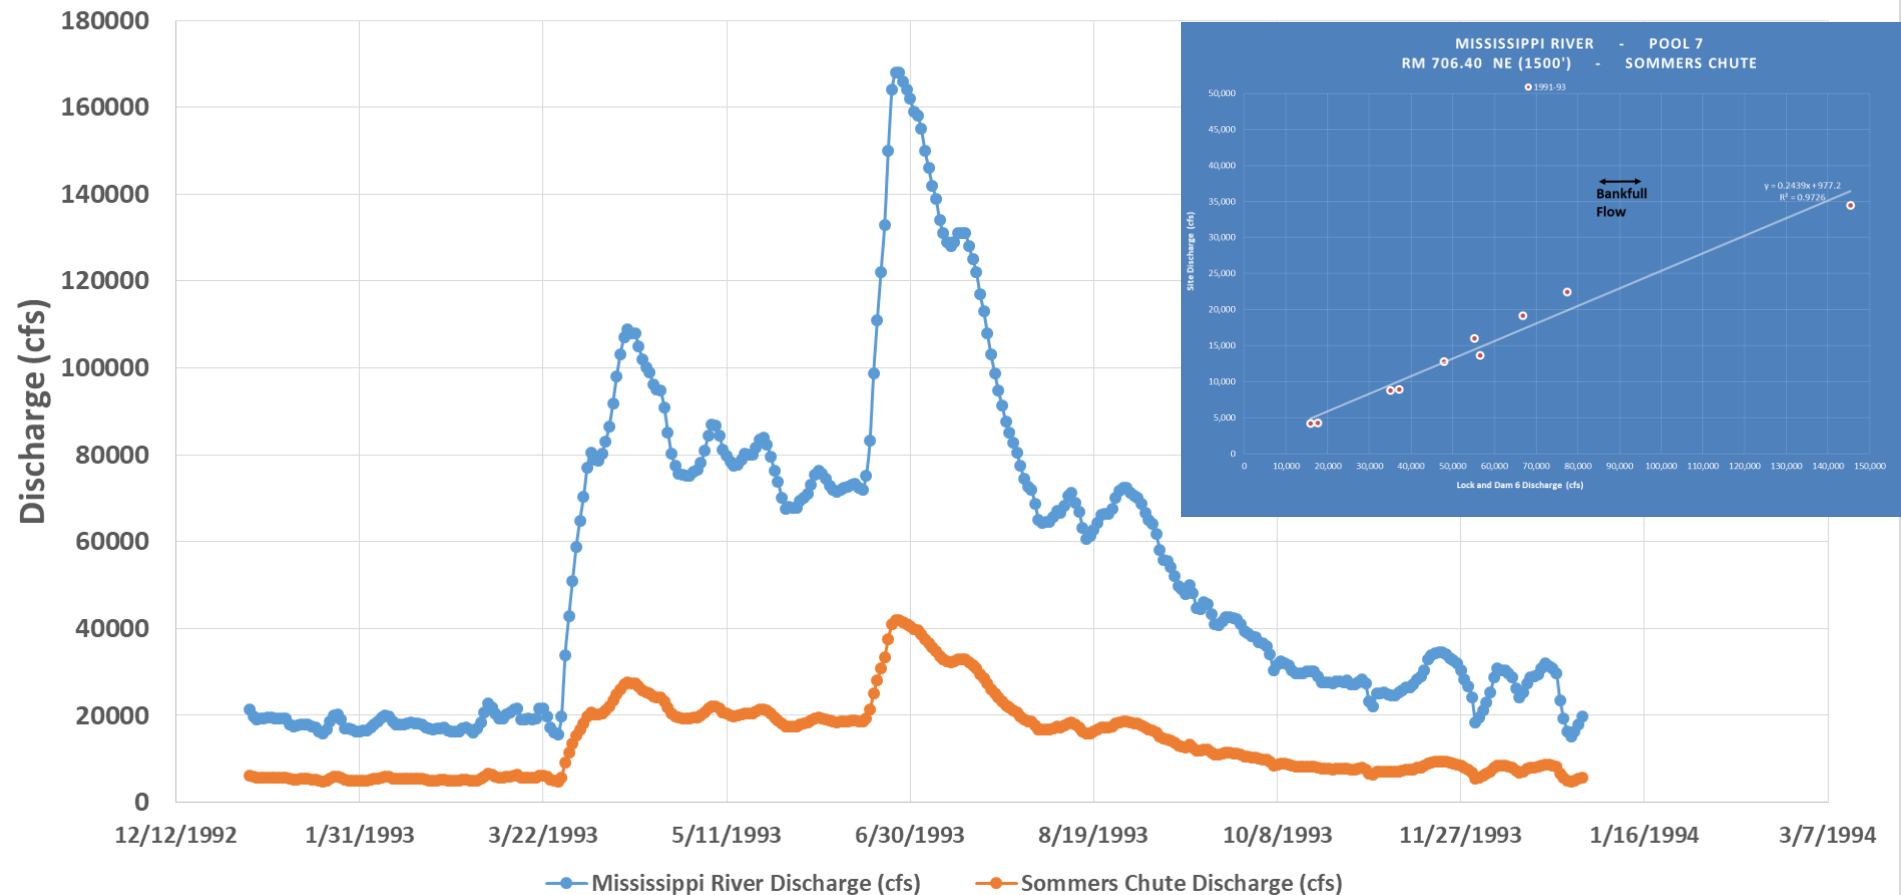
ESTIMATES OF DAILY WATER EXCHANGE

Discharge (cfs), Mississippi River and Sommers Chute, 1993

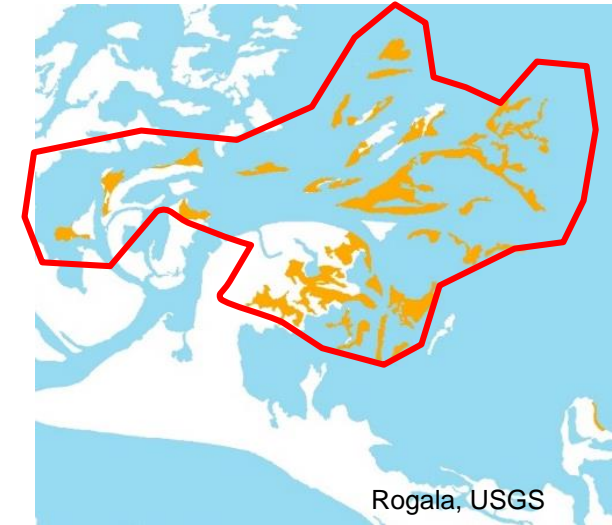
Hydrogeomorphic units

- Higher flow rates are accelerating geomorphic change:
 - Tributary sand loads????
 - Increased bank and shoreline erosion
 - Sediment Sinks are decreasing
 - Side Channel – Delta Change
- Pool 7 is Probably Most Significant Example to Date
 - Sediment Deposition
 - Altered flow patterns
 - Floodplain Forest Effects

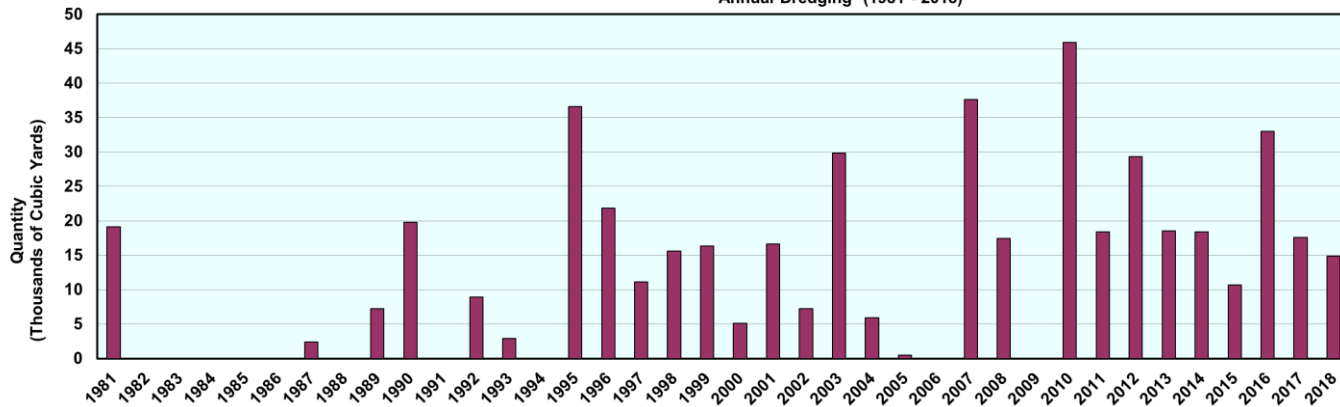
Mississippi River - Pool 7 - Lower Dresbach Island (RM. 703.0 - 703.7)
Annual Dredging (1981 - 2018)
