## October 20, 2022 Halfway Creek Marsh Project Tour Summary

Below and attached are edited notes from the October 20, 2022 tour of the Upper Halfway Creek Marsh Project. Many thanks to the US Fish and Wildlife Service for hosting the tour, and to the contributions from all of the participants.

The Lake Onalaska Protection and Rehabilitation District organized a US Fish and Wildlife Service-led tour of the Upper Halfway Creek Marsh project on Thursday October 20, 2022. Participants met at the Midway Bike Trail parking lot for introductory remarks, then carpooled to the project parking lot along County Highway ZN, and hiked the dike-top trails out to the inlet structure by the Great River trail. Most notes are from USFWS tour guide Tim Miller, with other contributors noted.

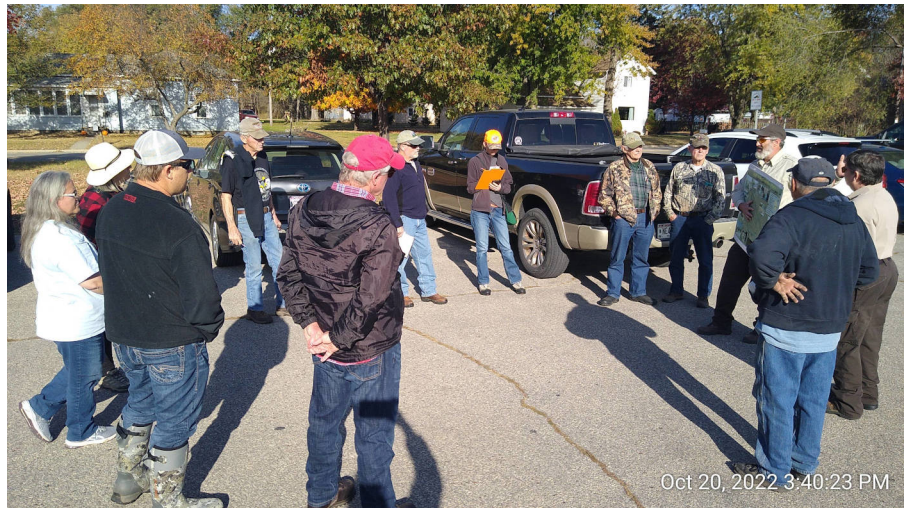
*Map of the three constructed wetland ponds of the Upper Halfway Creek Marsh Project*

The Upper Halfway Creek Marsh Project was initially constructed in 1999, and consists of three diked, constructed-wetland ponds designed to trap sediment and nutrients flowing from Halfway Creek. An inlet control structure from Halfway Creek is located just below the bridge where Halfway Creek passes under the Great River "Bike" Trail (see attached map), and adjustable culvert-dam structures control the flow between the three ponds and the outlet. Initial scoping for constructed wetlands and detention basins for Halfway Creek was part of Vierbicher Associates (1995) detailed recommendations to the Town of Onalaska following the severe flooding in Midway during the 1993 flood.

The project consists of three sediment-trapping, diked ponds:

Pond A 24 acres

Pond B 46 acres

Pond C 15 acres

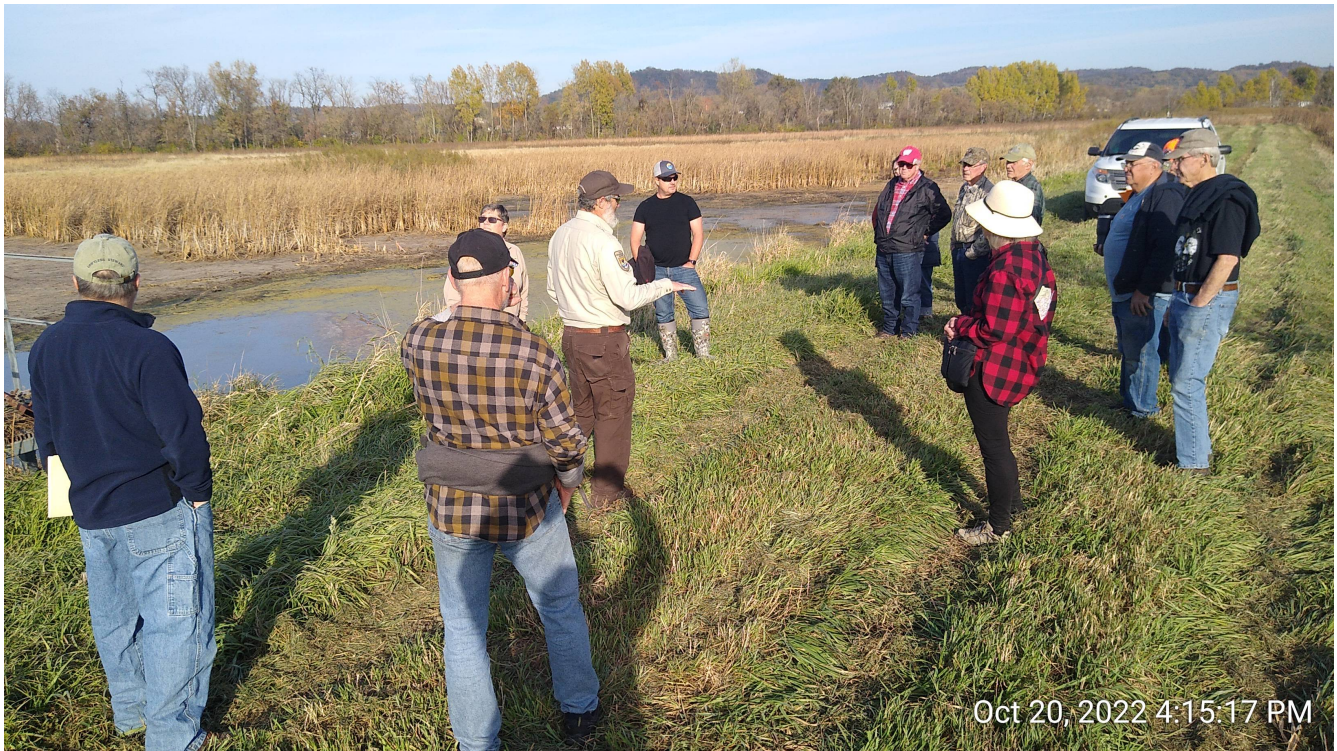
In the winter of 2020-2021, 6,187 cubic yards of sediment were removed from Pond A. Approximately 6" to 24" (by A--> B control structure) of new sediment had accumulated in Pool A. Strupp trucking was contractor, running 3-4 trucks daily, with multiple trips per truck, every morning until the tops of the levees started to get slick. Proceeds of sale of removed material as valuable topsoil helped to fund the removal. The removals were performed in winter when ice had stabilized the ground. The area of sediment removal can still be plainly seen in the bands of cattails.

*Group discussion at the outlet control structure from pond "A"*

Pool A also had sediment removed ~2007-2008, but a smaller amount. Marc Schultz recollects some small removals from Pond A in the 2000s by contractor Todd Wright.
